IOWA SITE INVENTORY FORM

Name of Property: Rebecca Nesbit Cottage

Rebecca Nesbit Cottage
517 North Ripley St., Davenport IA 52803
Part: 1
Map

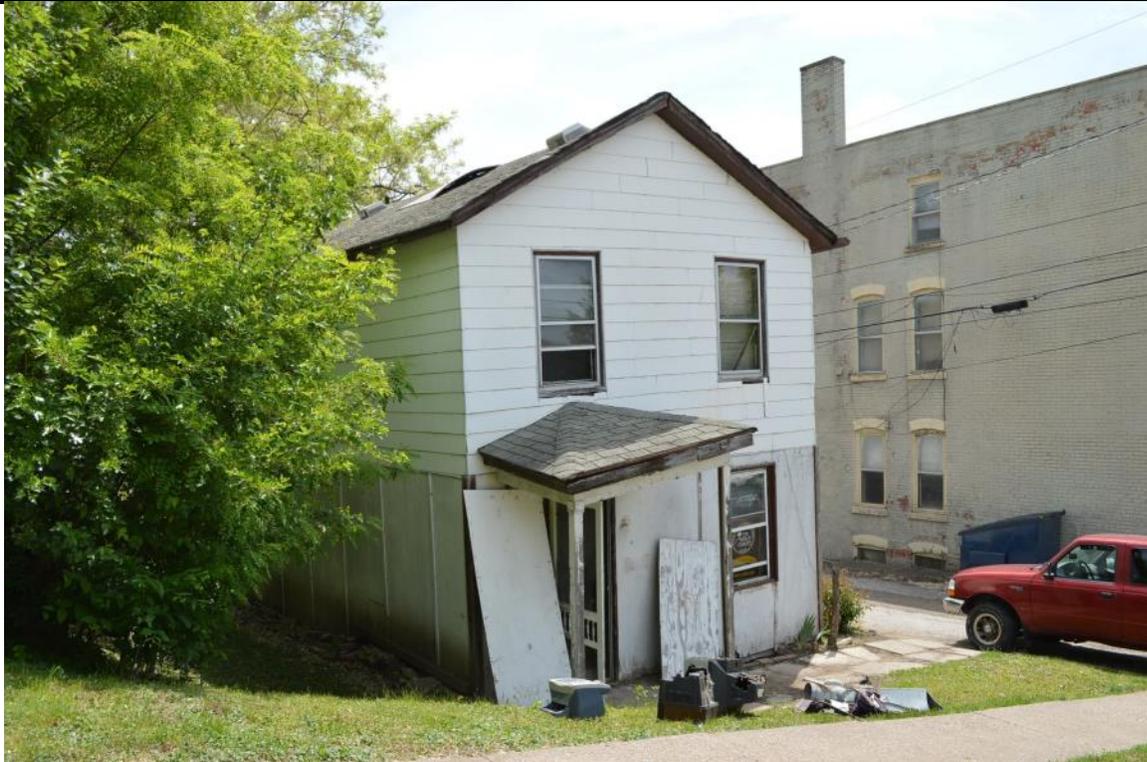
Part 1 Photo #: 8
Name: Rebecca Nesbit Cottage
Address: 517 Ripley St., Davenport, IA 52803
Date: 5/26/2016
View: Looking SE, collapsing porch roof. Note moss and stain at north sill.

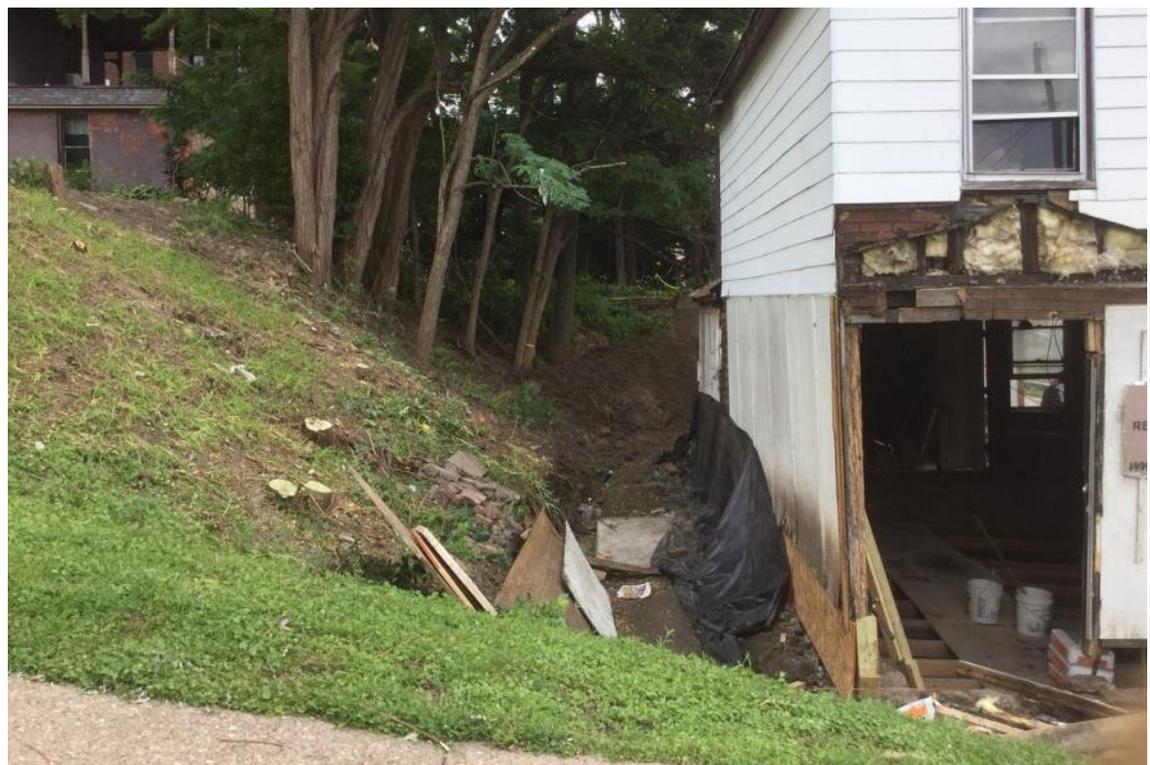
View: Looking E, slope at
north side of property after
some foliage is removed.
The topography and condi-
tions created a damp envi-
ronment against the N sill.

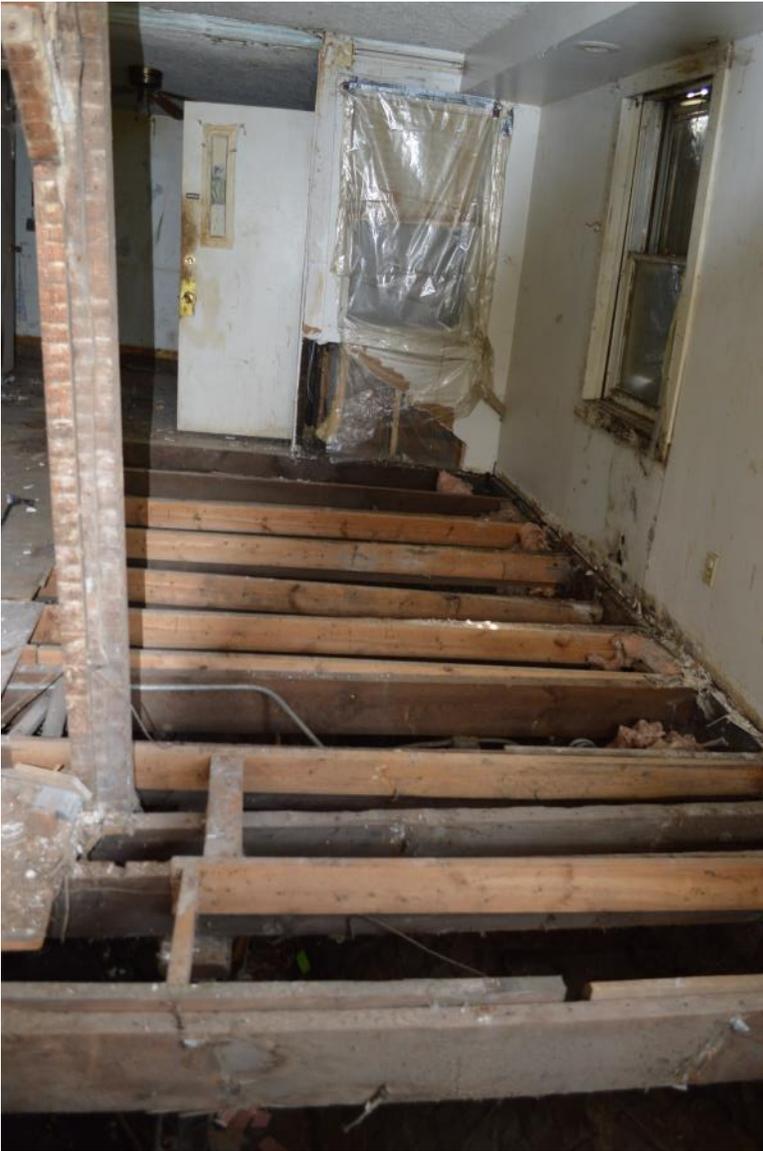
Part 1 Photo #: 21

View: Looking E, 1st floor. With plywood floor removed, sistered joists become visible.

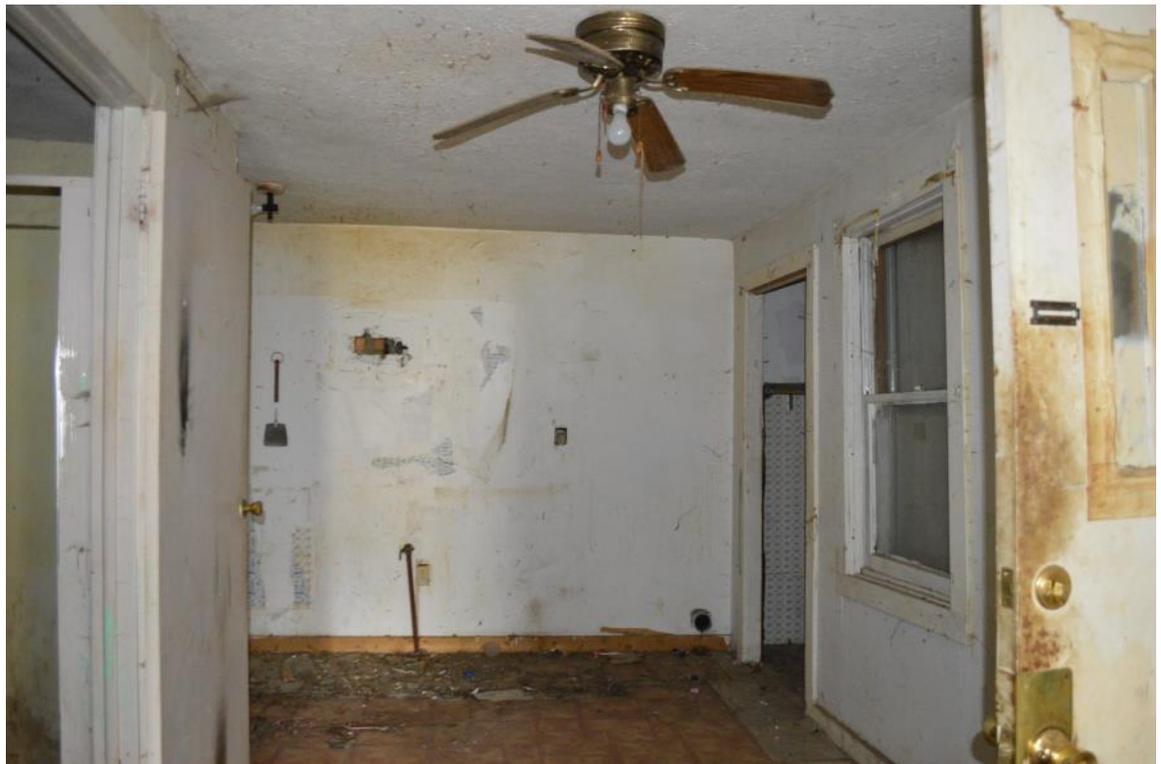
Part 1 Photo #: 22

View: Looking E, at door
of bathroom to kitchen
area. Floor still in kitchen
but very unstable.

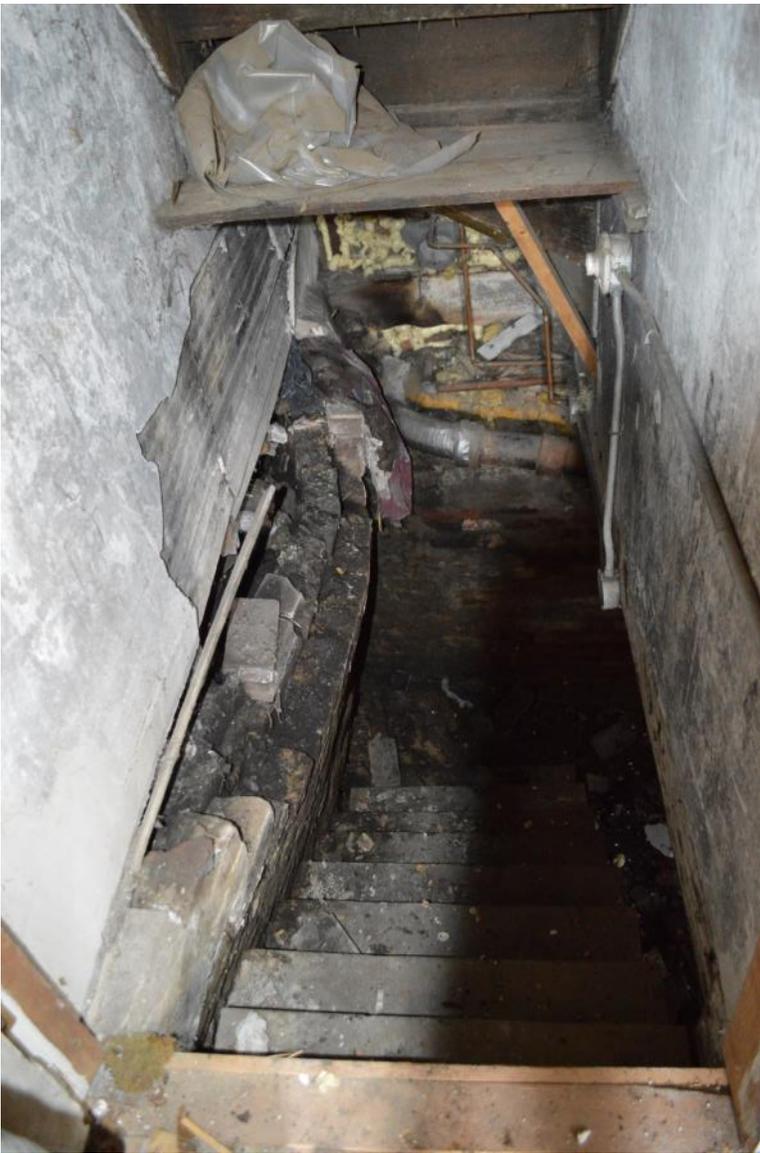
Part 1 Photo #: 25
Name: Rebecca Nesbit Cottage
Address: 517 Ripley St., Davenport, IA 52803
Date: 5/25/2016
View: Looking E, stair to basement. Collapsing wall due to moisture pushing in foundation and general wall failure.

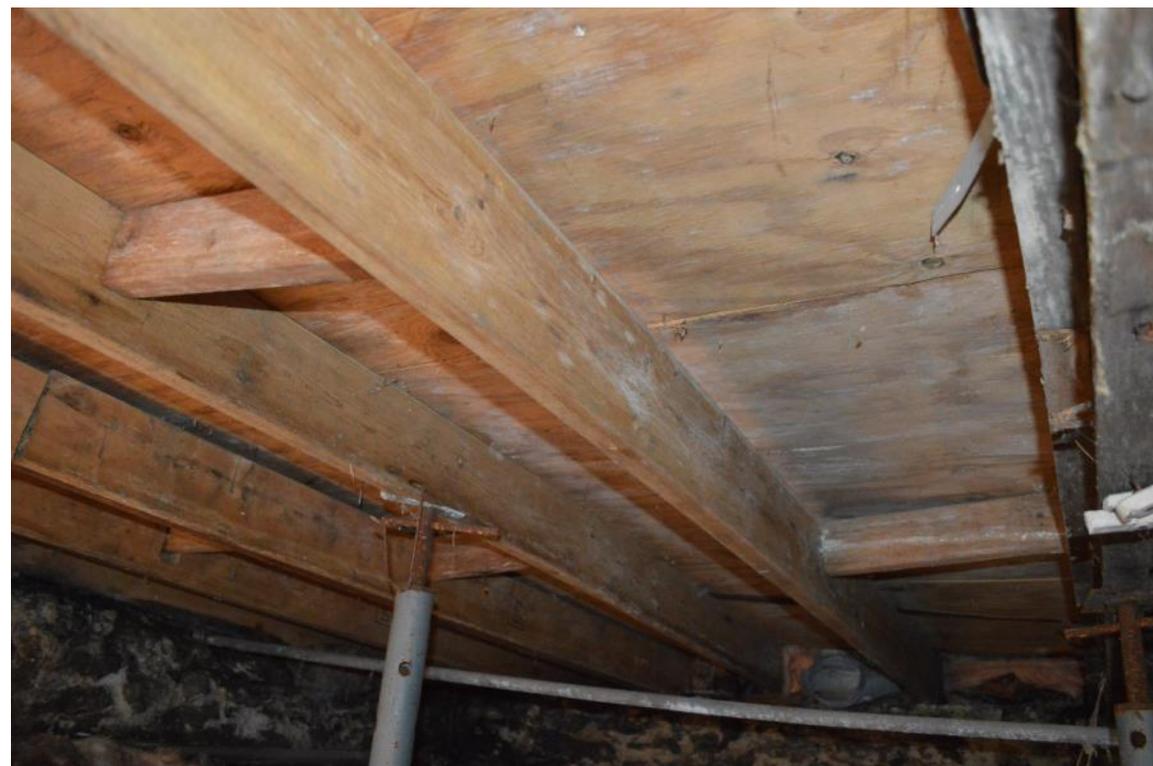
At an earlier time, the first floor flooring was removed and the joists sistered to raise what had likely become an angled floor due to sill deterioration. The joists were then covered by plywood and carpeting was installed on top. **(Photos 21, 27, 38)** Apparently, there was no attempt at this time to deal with the real issue which was the sills. In the one story area over the crawl space, blown in insulation had filled the cavity, but the crew failed to provide any ventilation into the space. The floor joists were rotted and the later plywood covering was severely damaged as a result.

Part 1 Photo #: 27
Name: Rebecca Nesbit Cottage
Address: 517 Ripley St., Davenport, IA 52803
Date: 5/25/2016
View: Looking N, from basement; sistered floor joists and plywood sheet flooring.

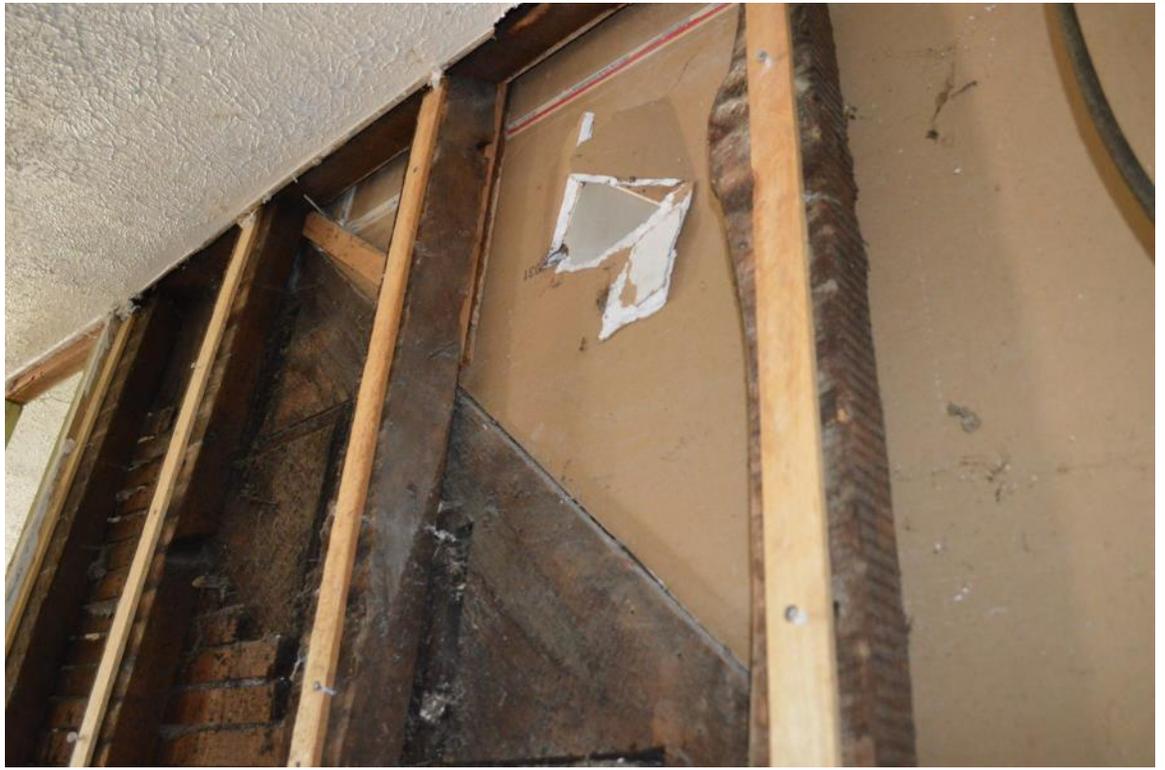
An examination of the sills from inside the building at the basement level reveal much moisture and pest damage to most of the building's first floor sills. The north sill is completely disintegrated by both moisture and termites. The south and west sills are also dangerously deteriorated. The east sill is sound. **(Photo 40)**

Part 1 Photo #: 40
Name: Rebecca Nesbit Cottage
Address: 517 Ripley St., Davenport, IA 52803
Date: 5/25/2016
View: Looking N, 1st floor, north wall; condition of one of
the 4 x 4 timbers with termite infestation. Damaged
reached to almost 6 feet. Note weatherboard nailed di-
rectly to timber and lack of sheathing.

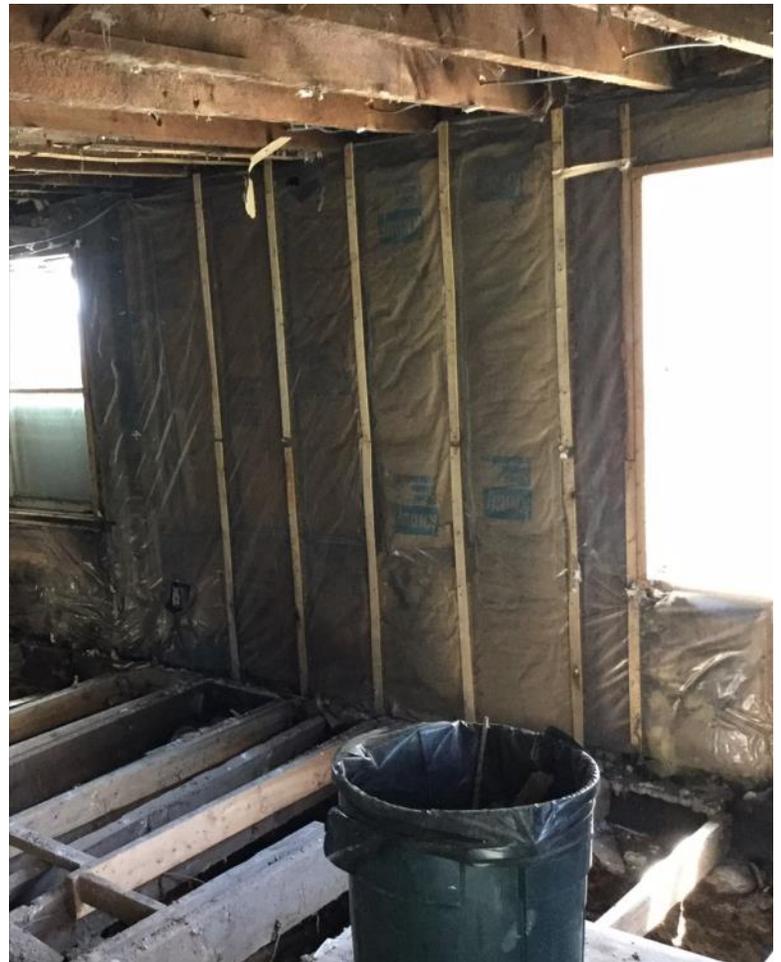
Part 1 Photo #: 42

that make up the building's skeleton. Had the weatherboarding not been protected by later exterior coverings, addition of insulation and polyurethane right against the exterior cladding would have created even more serious issues with moisture than the building already faces.

View: Looking SE, south wall. Insulation placed in wall pockets directly against exterior weatherboarding. Stringers added to studs to act as spacers for drywall.

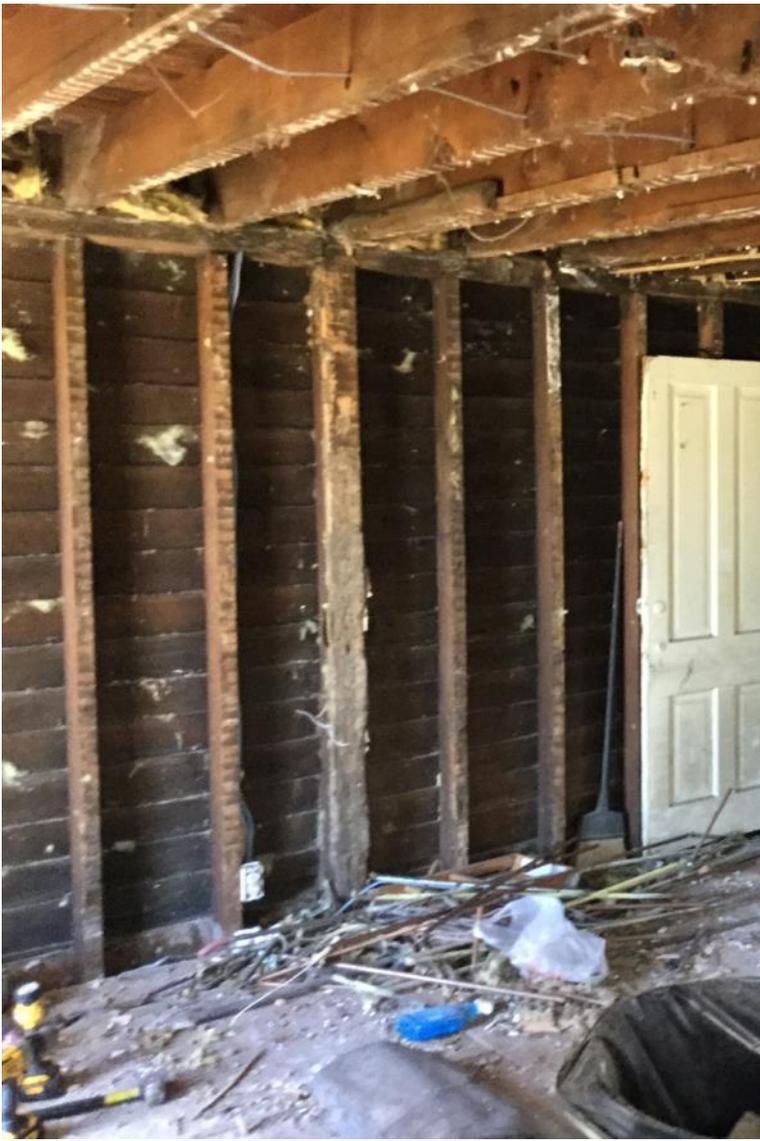
Part 1 Photo #: 43

View: Looking NE, first floor north wall. Drywall and insulation removed, showing weatherboarding attached to studs. At this point, these studs are sitting on foundation as north sill has disintegrated.
