IOWA SITE INVENTORY FORM

Name of Property: Rebecca Nesbit Cottage

Rebecca Nesbit Cottage
517 North Ripley St., Davenport IA 52803
Part: 1
Map

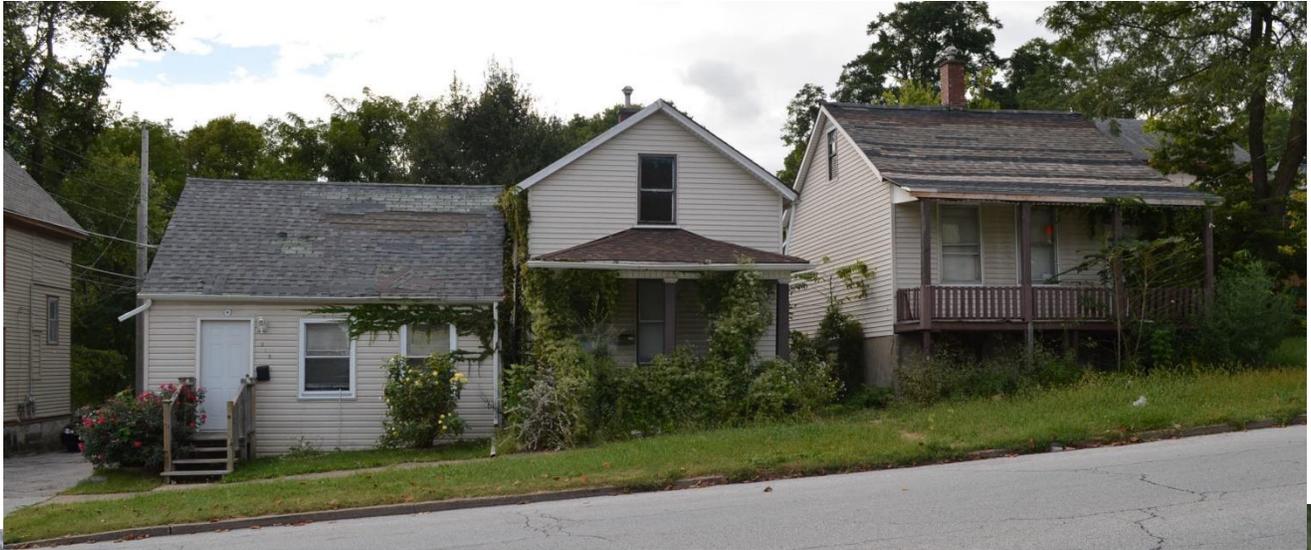
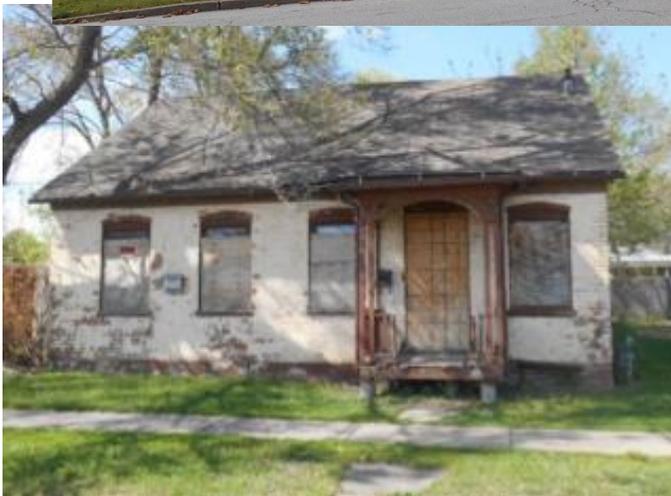
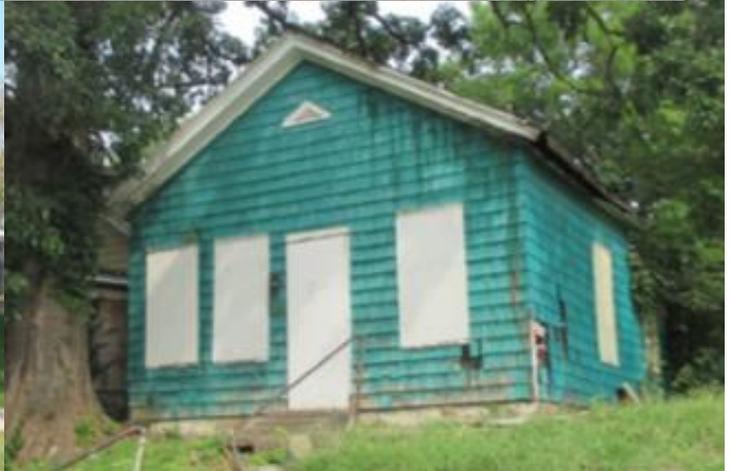
Figure 4. Hamburg cottages in poor and derelict condition. Top, Gaines Street between 5th and Ripley. The cottage to the left is occupied. Those to the right are not. The building to the right is 522 Gaines Street and the 1861 Petersen house.

Below, left, 924 W. 5th. The 1857 Ruhl House. Vacant and boarded. Deteriorated wall conditions in some areas.

Today, most of the Hamburg's surviving cottages are abandoned and in poor condition. Two buildings on 8th Street placed on the city's 2015 active demo list were removed only after residents intervened. Three other small buildings along Gaines between 5th and 6th are both vacant and severely deteriorated. In 2015, the 1863 Tegrunde cottage at 928 6th Street was demolished despite being occupied and meeting city codes because the not for profit next door wanted green space. **(Figs. 4 & 5)**

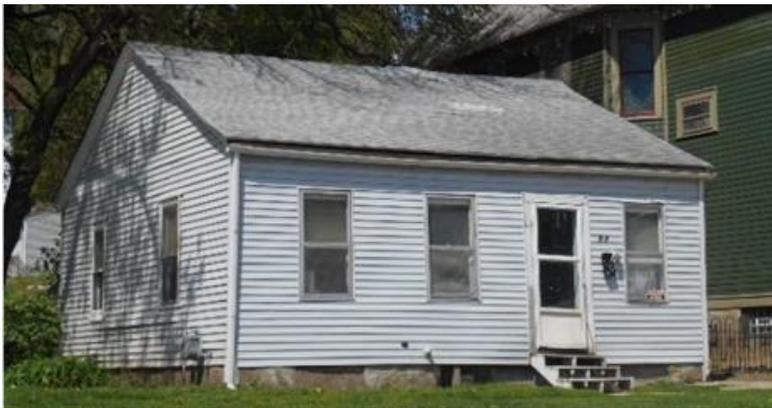
Figure 5. The Dietrich Tegrunde House, 1863. Increasingly rare ante-bellum example of workman's house in the district. Wood clapboard concealed by asphalt brick underneath aluminum siding. Functional rental at the time of demolition. Demolished 2015 to create green space.

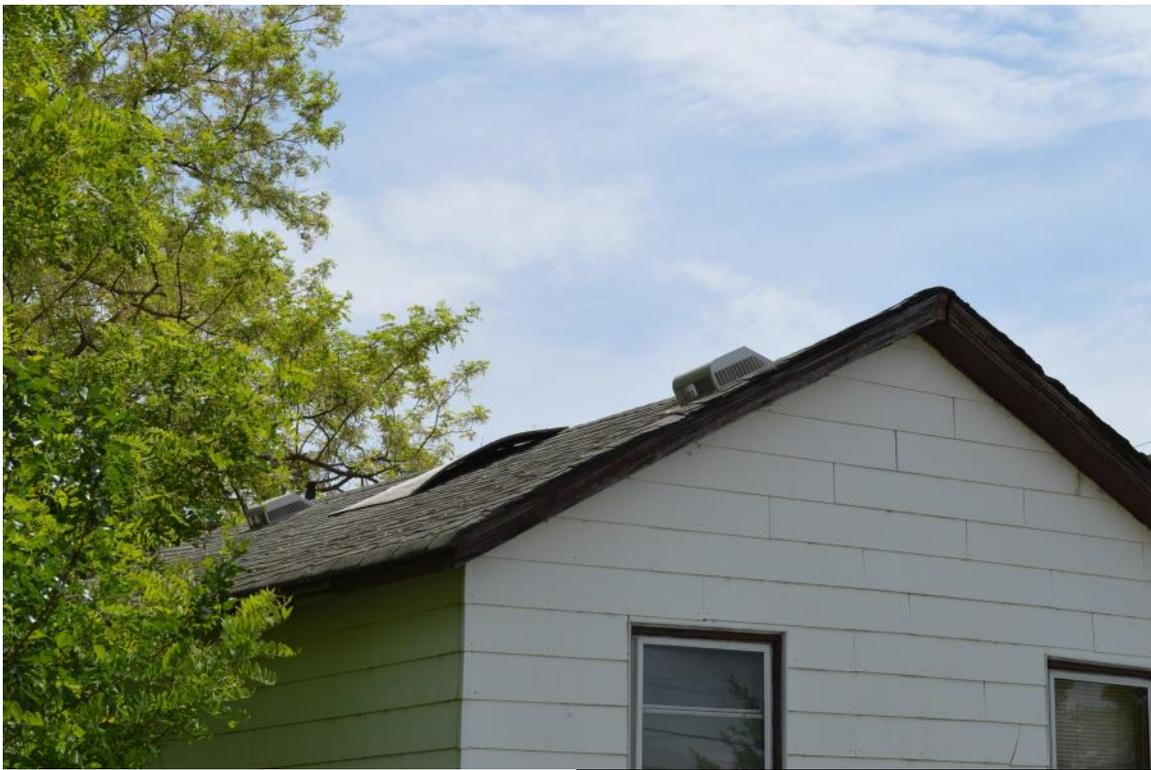
The house is topped with an asphalt roof covering three older asphalt roofs and at least one layer of wood shingles.

Part 1 Photo #: 9
Name: Rebecca Nesbit Cottage
Address: 517 Ripley St., Davenport, IA 52803
Date: 5/25/2016
View: Looking SE, roof.

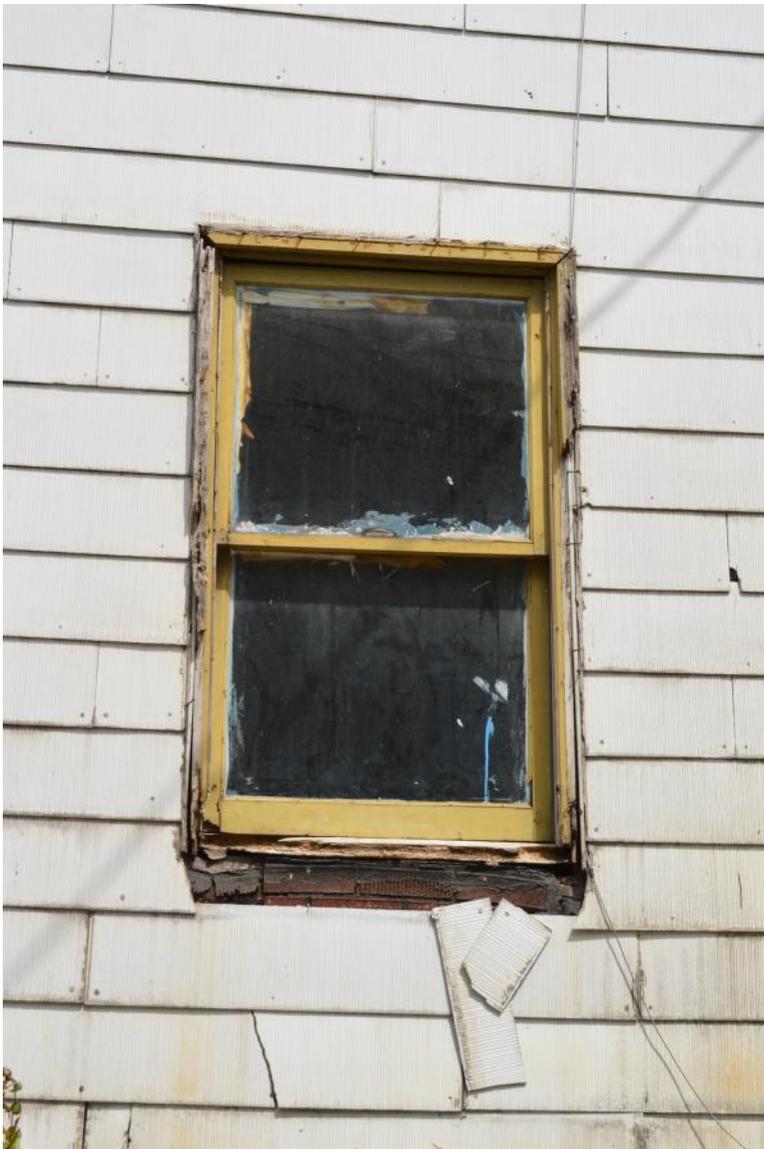
Part 1 Photo #: 10
Name: Rebecca Nesbit Cottage
Address: 517 Ripley St., Davenport, IA 52803
Date: 5/25/2016
View: Looking N, first floor window. As was the case in the 1910 photo, there is limited exterior framing. Six over six windows replaced with single light double hung sashes.

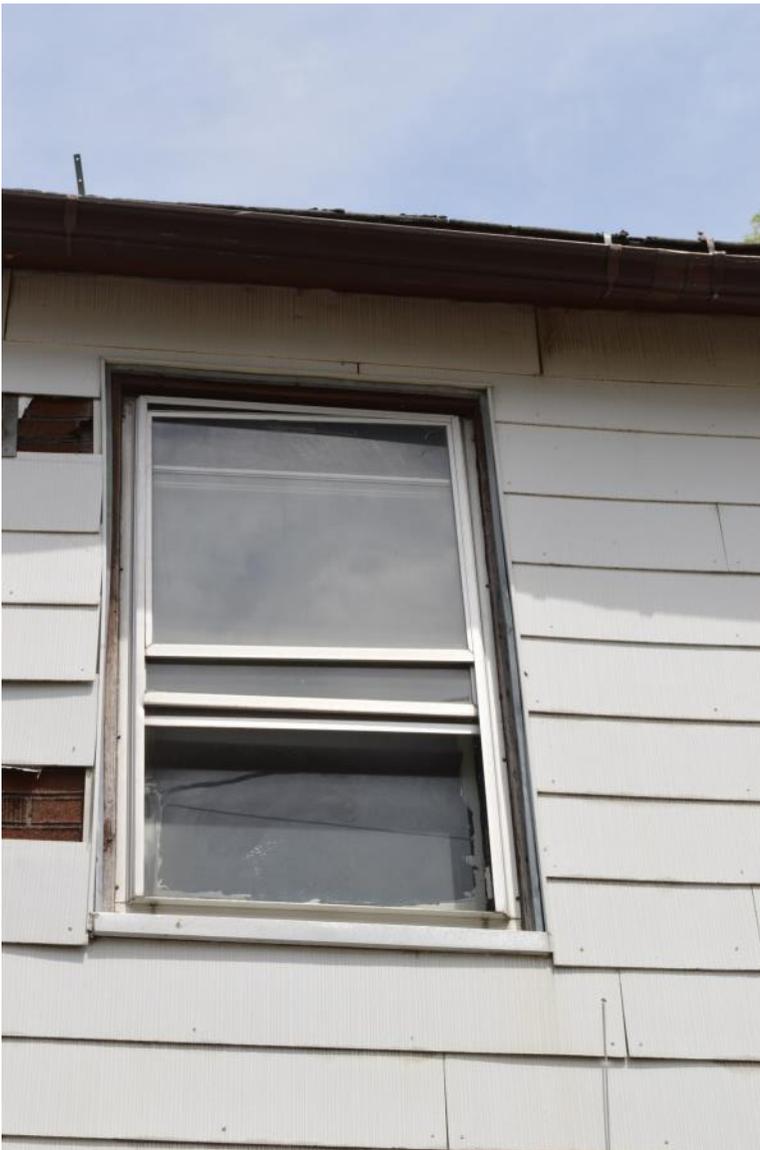
Part 1 Photo #: 11

View: Looking N, second floor replaced window and minimal trim. Aluminum storms over wood sashes.

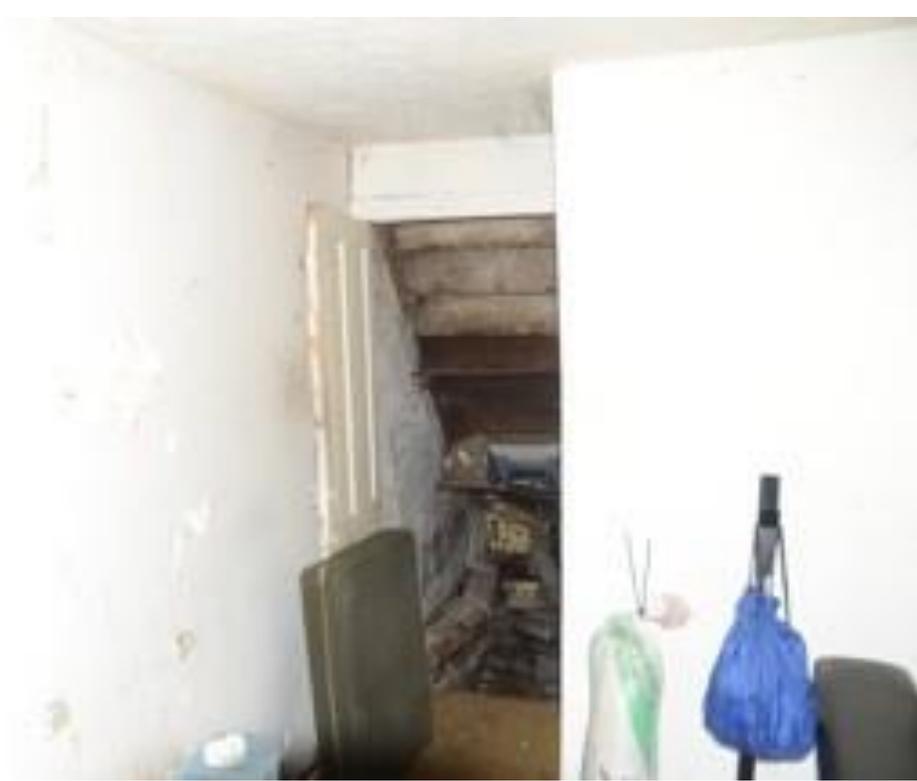
Part 1 Photo #: 17

View: Looking NE, staircase to basement. Half wall on right was modern stud and drywall construction for duct run.

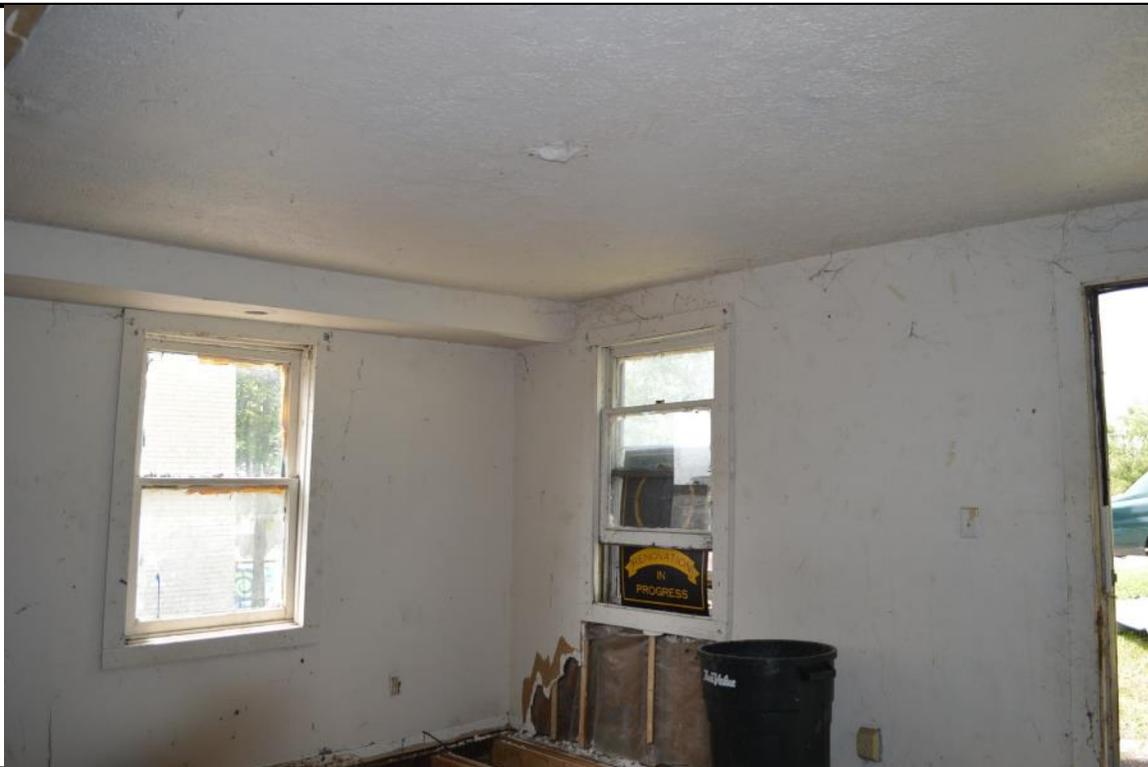
Part 1 Photo #: 20

View: Looking SW, first floor before removal of drywall. Window frames on interior were also replacements.

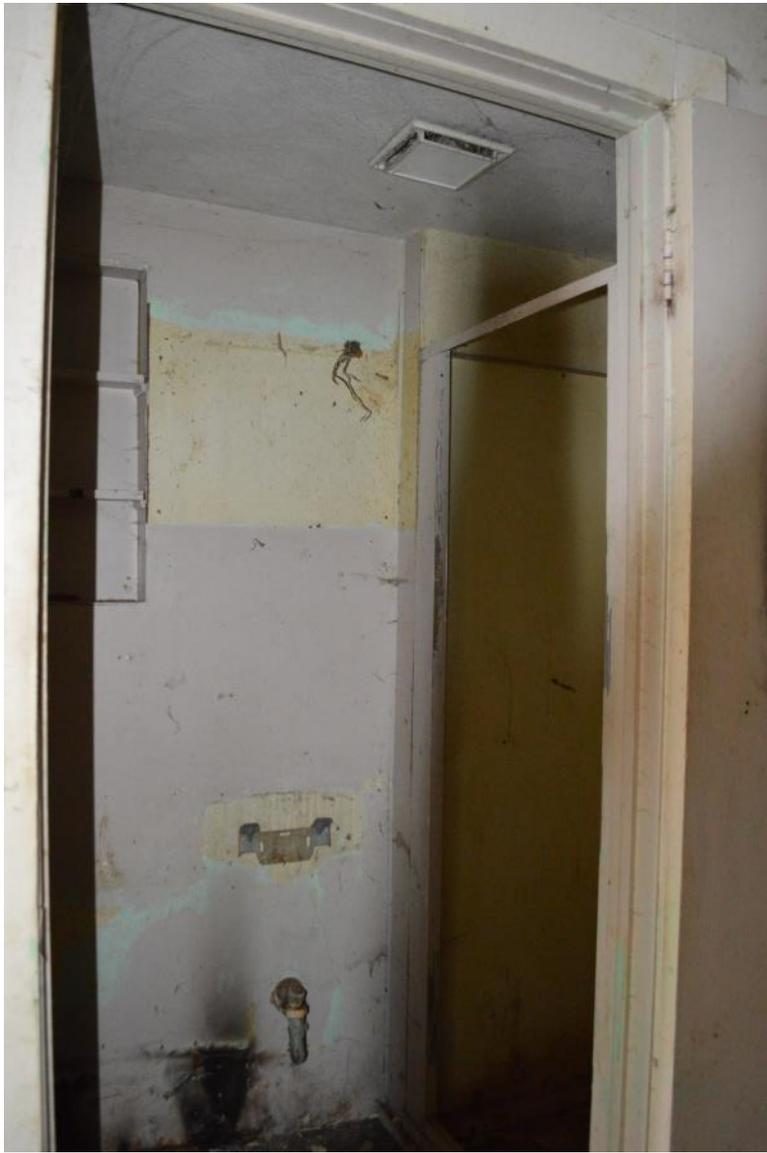
Part 1 Photo #: 23
Name: Rebecca Nesbit Cottage
Address: 517 Ripley St., Davenport, IA 52803
Date: 5/25/2016
View: Looking NE, 1st floor bathroom which contains only window on north elevation on this floor.

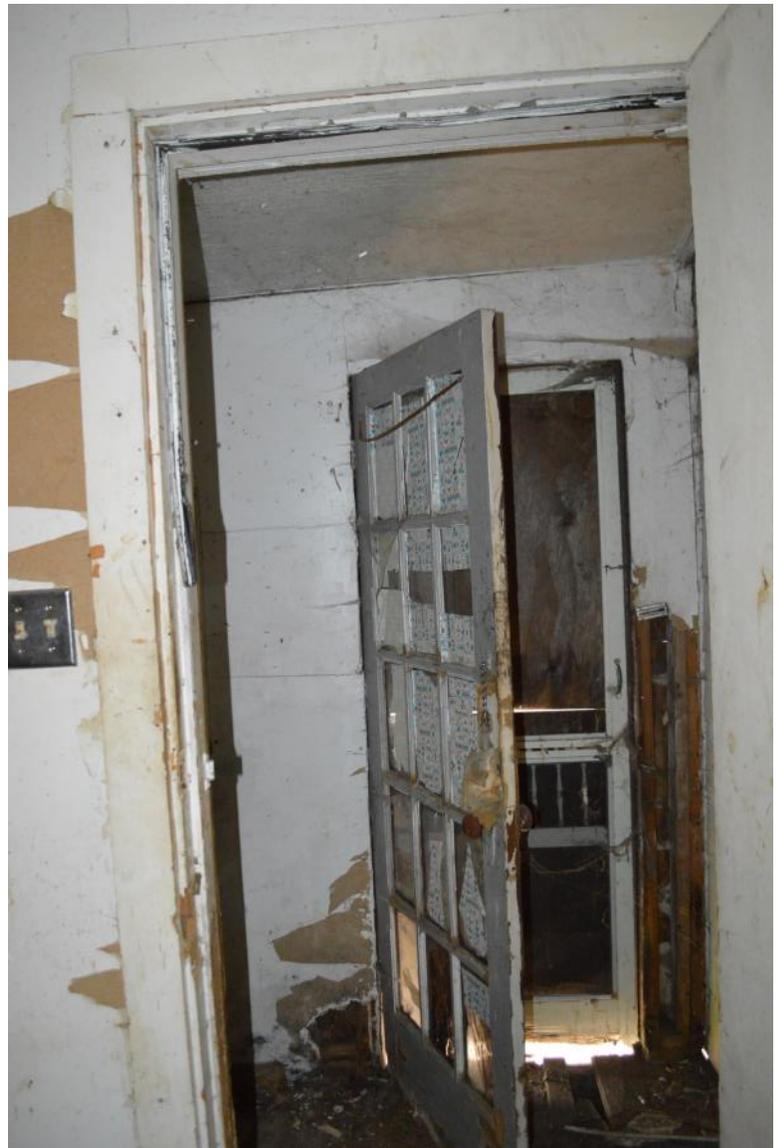
Part 1 Photo #: 24
Name: Rebecca Nesbit Cottage
Address: 517 Ripley St., Davenport, IA 52803
Date: 5/25/2016
View: Looking S, porch with added wall still intact.

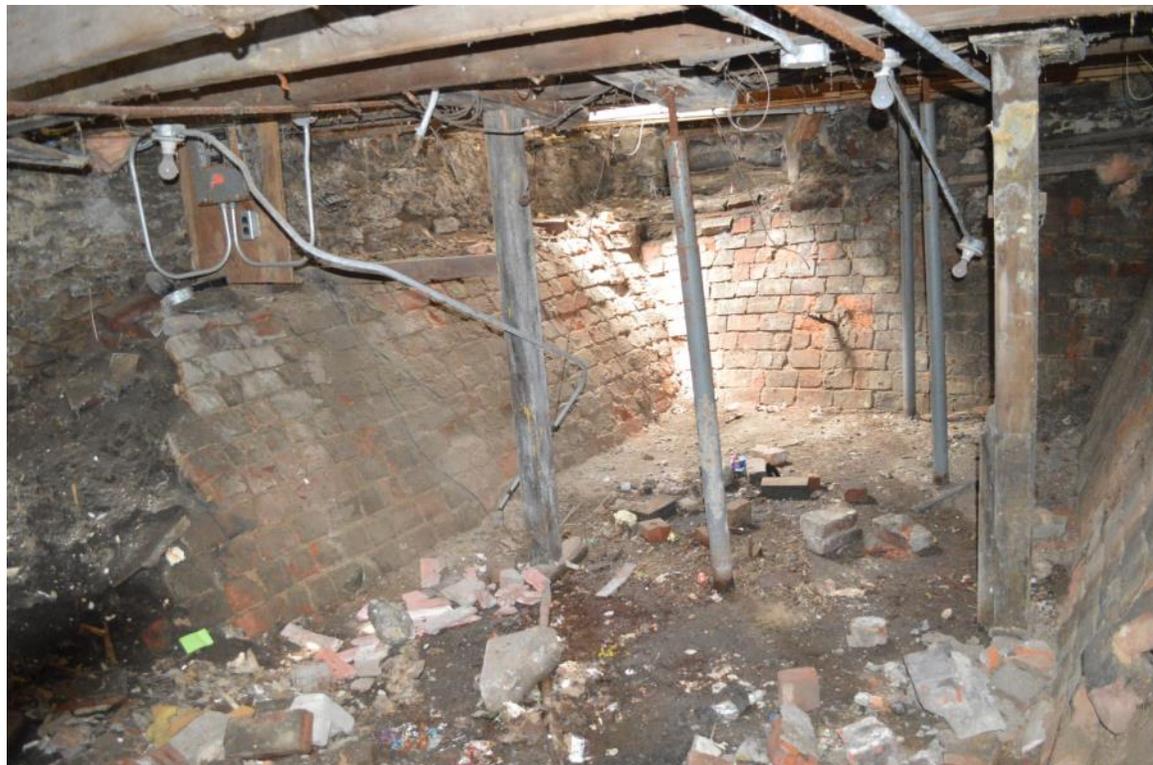
The front section rests on a limestone rubble foundation. A basement with battered brick walls sits beneath this part of the building. (Photos 25, 26). The rear section sits over a crawlspace ranging in height from 18 to 22"; the foundation is later concrete block.

Part 1 Photo #: 26
Name: Rebecca Nesbit Cottage
Address: 517 Ripley St., Davenport, IA 52803
Date: 5/25/2016
View: Looking SW, battered brick walls in basement. In good shape except for area at right where bricks had been displaced to install sewer and along parts of the collapsing N wall.

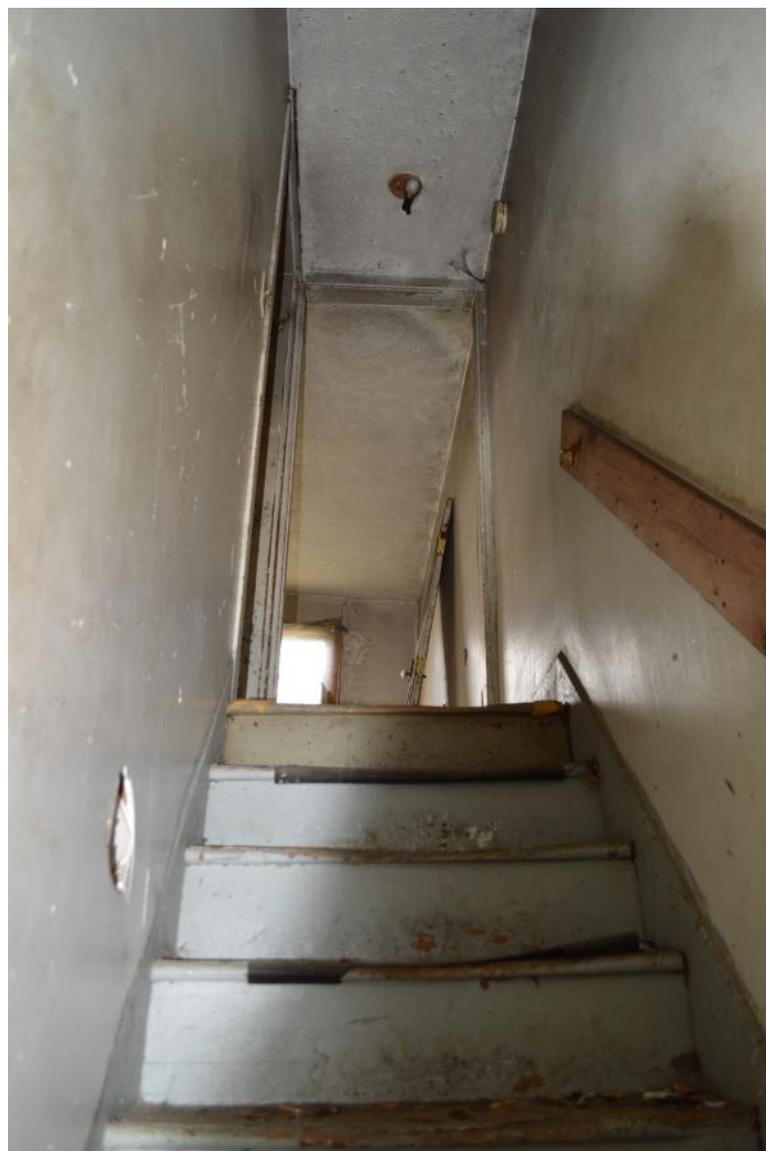
The enclosed narrow staircase leading to the second floor has had some treads replaced with plywood. At the top of the stairs is a small landing. Doors to two rooms open onto the landing. The room to the east has a small closet. Plaster was removed from the exterior walls on the second floor and replaced with drywall so that insulation bats could be installed. However, original ceiling plaster and the original fir flooring is still intact. **(Photos 28-37)**

Part 1 Photo #: 28
Name: Rebecca Nesbit Cottage
Address: 517 Ripley St., Davenport, IA 52803
Date: 5/25/2016
View: Looking W, stairs leading to 2nd floor.

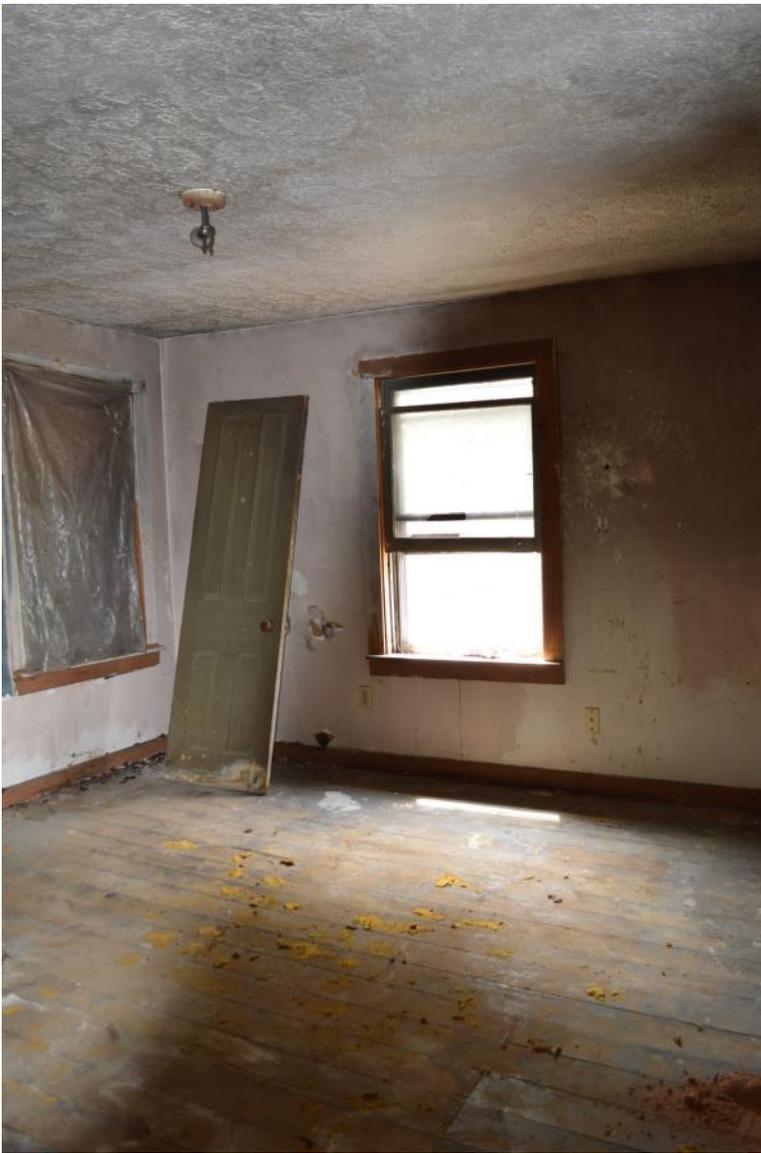
Part 1 Photo #: 29
Name: Rebecca Nesbit Cottage
Address: 517 Ripley St., Davenport, IA 52803
Date: 5/25/2016
View: Looking S, Bedroom 1. Original wood flooring. Ceiling has been textured.

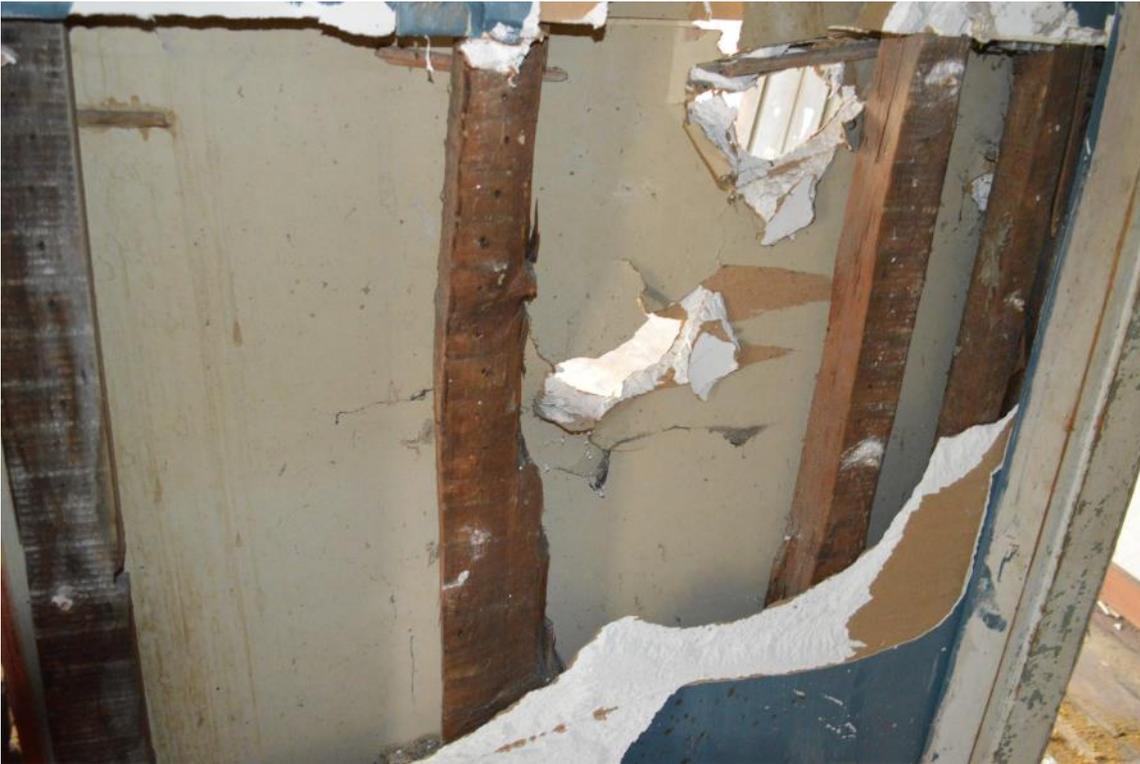
Part 1 Photo #: 31
Name: Rebecca Nesbit Cottage
Address: 517 Ripley St.,
Davenport, IA 52803
Date: 5/25/2016
View: Looking W, Bed-
room 1. Plaster and lath
replaced with drywall.
Note crudeness of stud in
wall.

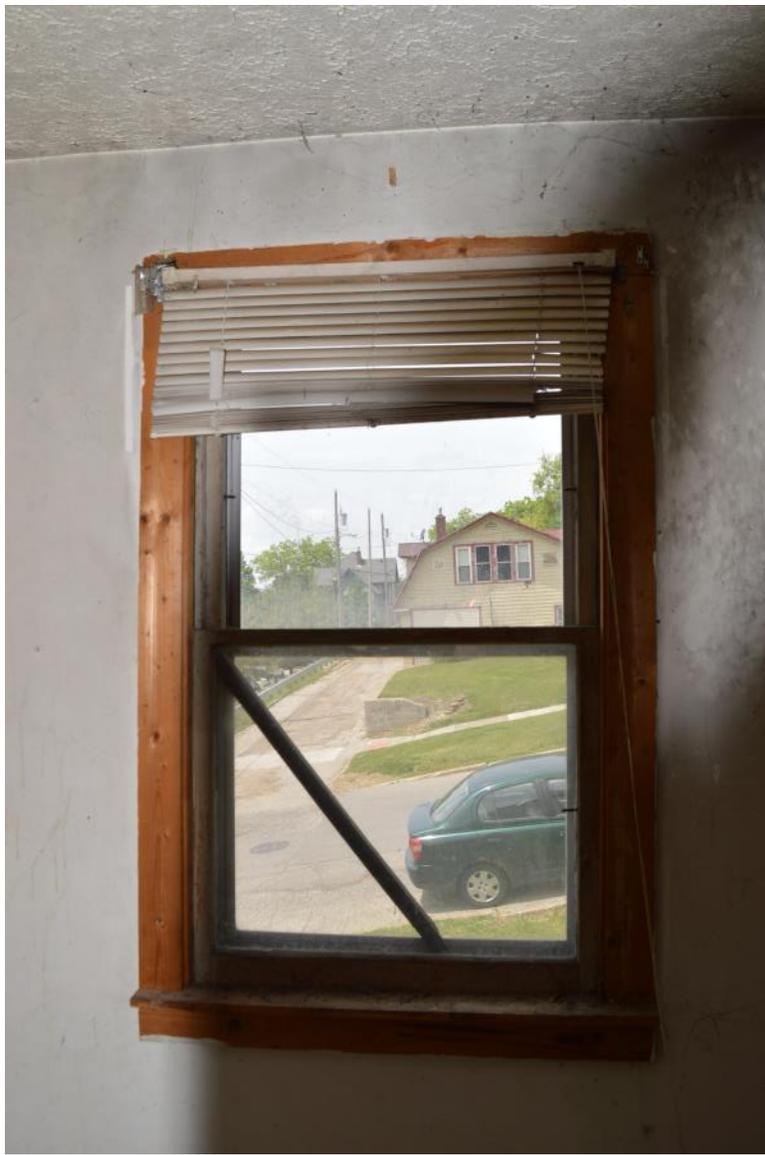
Part 1 Photo #: 37
Name: Rebecca Nesbit Cottage
Address: 517 Ripley St., Davenport, IA 52803
Date: 5/25/2016
View: Looking W, bedroom 2 window. Note re-
placed window trim.

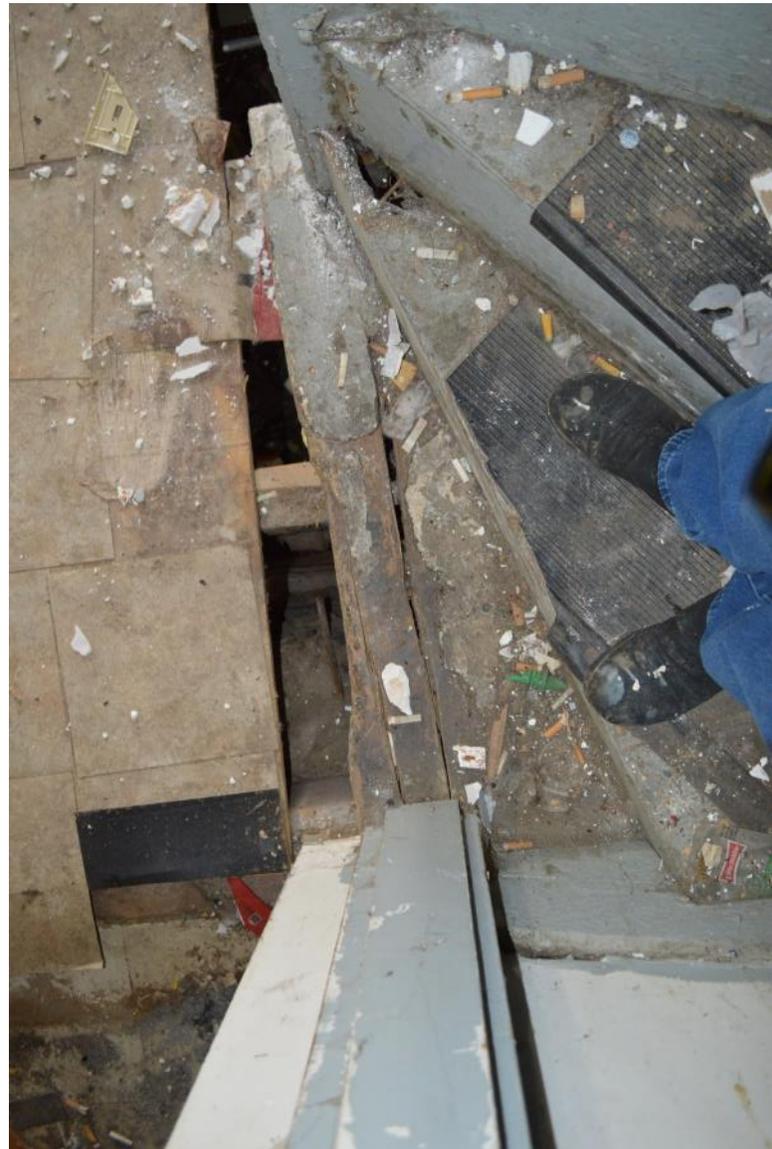
Part 1 Photo #: 38
Name: Rebecca Nesbit Cottage
Address: 517 Ripley St., Davenport, IA 52803
Date: 5/25/2016
View: From staircase, looking down to condition of
flooring on first floor.

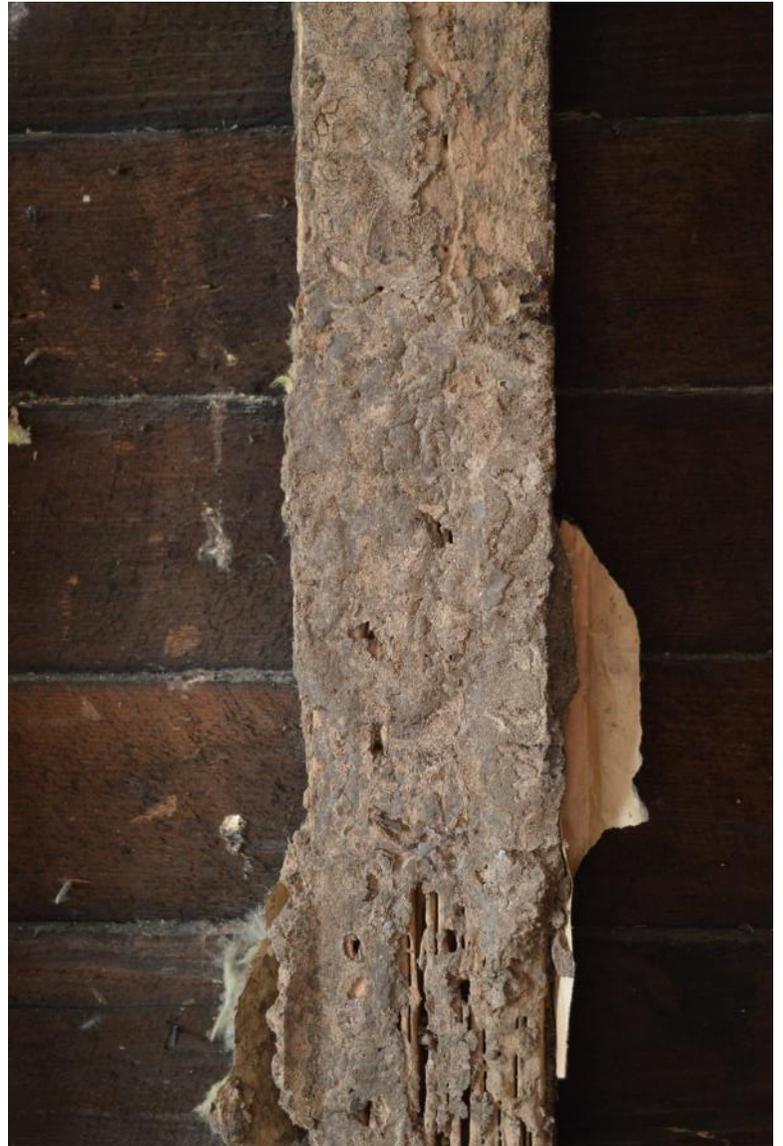
An examination of the sills from inside the building at the basement level reveal much moisture and pest damage to most of the building's first floor sills. The north sill is completely disintegrated by both moisture and termites. The south and west sills are also dangerously deteriorated. The east sill is sound. **(Photo 40)**

Part 1 Photo #: 40
Name: Rebecca Nesbit Cottage
Address: 517 Ripley St., Davenport, IA 52803
Date: 5/25/2016
View: Looking N, 1st floor, north wall; condition of one of
the 4 x 4 timbers with termite infestation. Damaged
reached to almost 6 feet. Note weatherboard nailed di-
rectly to timber and lack of sheathing.

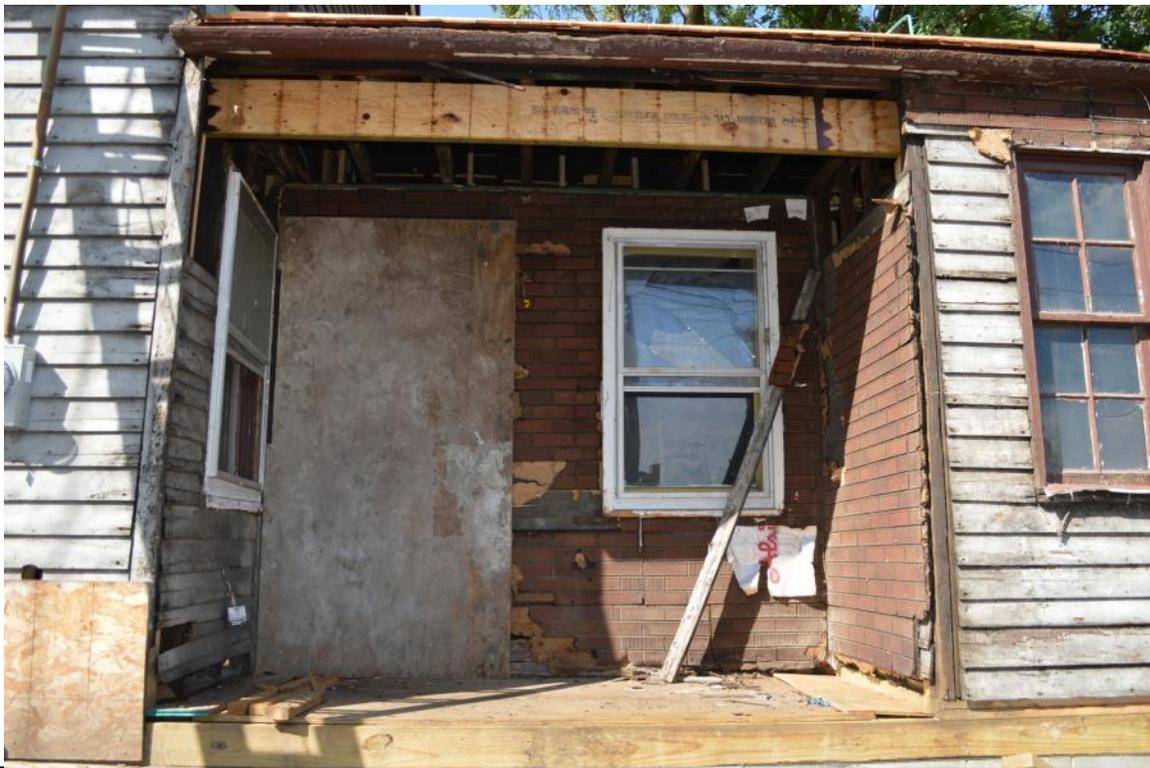
View: Looking NW, south elevation. Front section. South sill replaced, later cladding removed.
